**Should the quality assessment of an optical multi-fibre splitter cable for indoor installation be carried out according to DIN EN 60794-2-20/ 60794-1-21 or the client's technical data sheet?**

## A General information required by Fibre Optics CT GmbH to judge the performance of an optical cable under operational conditions

## Fibre Optics CT Fault analysis

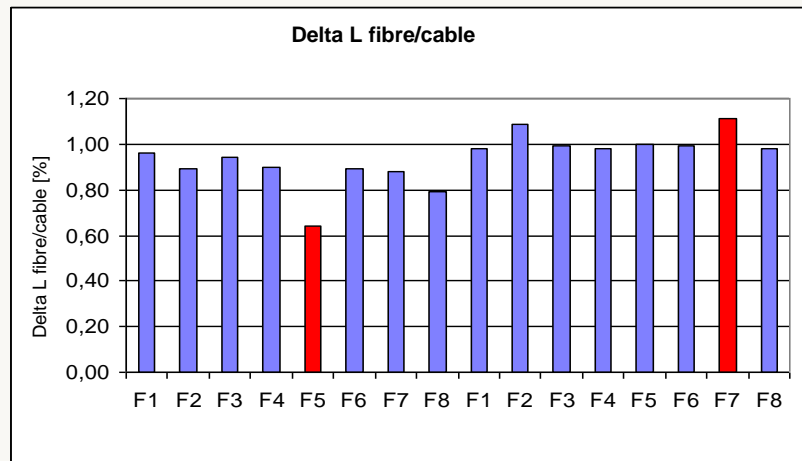
## B Example: "cabled fibre overlength" (test results on a bundle-stranded cable)

Cable length 13.220 mm

Fibre length:

min: core 1, fibre 5

13.305 mm

max: core 7, fibre 7

13.366 mm

$\Delta l$  min/max length:

actual 0.5456%

specified  $\leq 0.1\%$

Requirement according to standards: none  
 according to Fibre Optics CT GmbH: extremely important

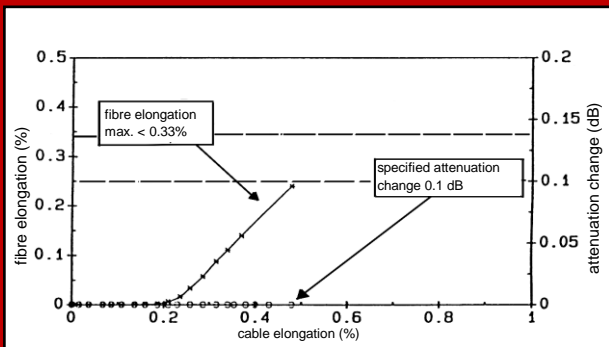
**Cable with central loose tube**  
A-D(ZN)2Y 1x10 E9/125...zD

- calculated fibre overlength 0.2%
- max. admissible attenuation change under tensile stress [dB]  
SM fibres in 1310 nm  $\leq 0.05$  dB range

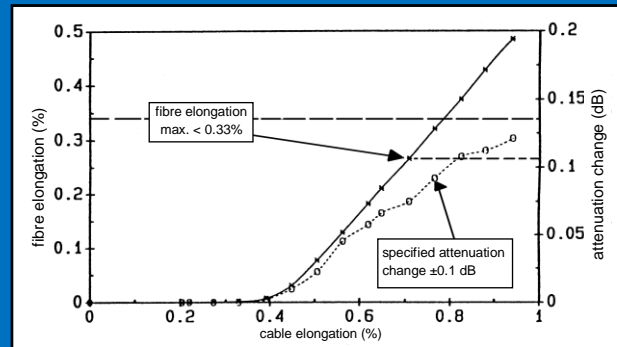
**Cable with layer-stranded loose tube (S/Z stranding)**  
A-DF(ZN)2Y 4x2 E9/125...Lg

- calculated fibre overlength  
S/Z-stranding 0.37 %  
helical stranding 0.45 %
- max. admissible attenuation change under tensile stress [dB]  
SM fibres in 1310 nm  $< 0.05$  dB range

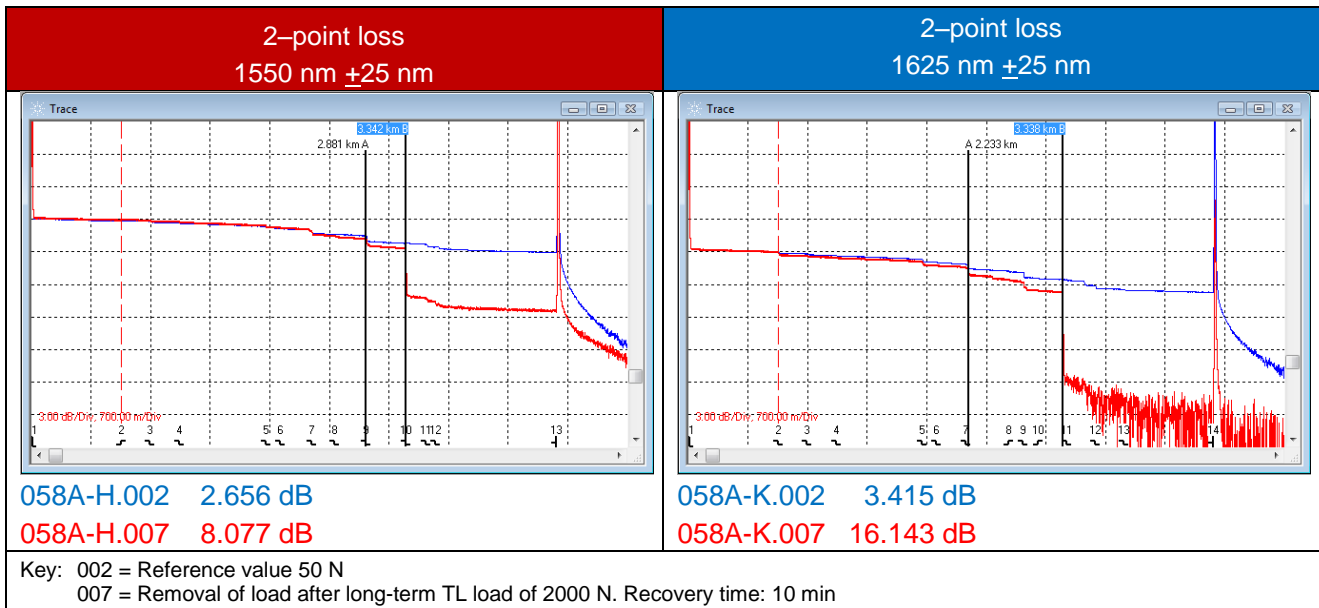
## Comparison 3: Tensile strength

Attenuation change  $\Delta\alpha$  during and after testing at highest wavelengths  
1550 nm  $\pm$  25 nm and 1625 nm  $\pm$  25 nm

### Test results:

- No attenuation change  $\Delta\alpha$  during the TS (short-term) and TL (long-term) tests
- No irreversible attenuation change after the test
- No visible damage to the cable/ cable elements

**No method has been defined for evaluating visible damage!**

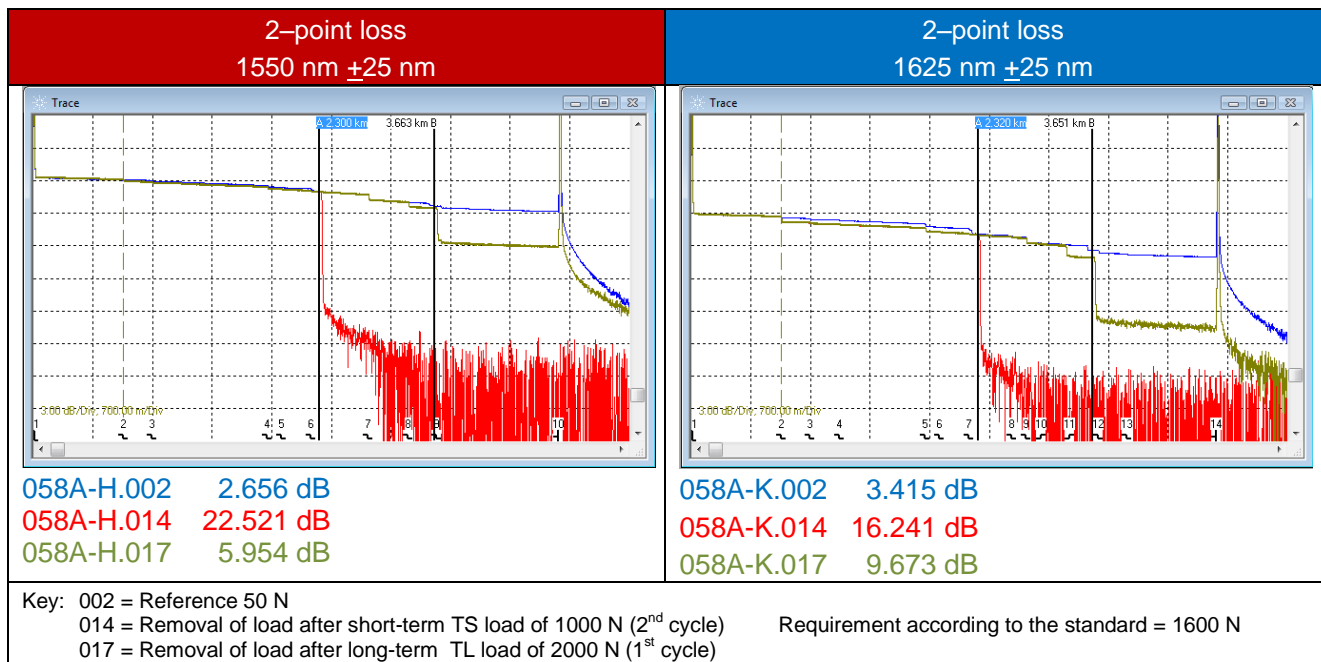
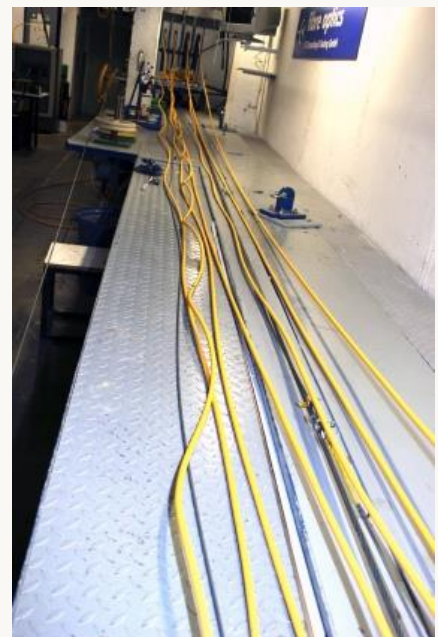
## Comparison 4: Cable bending under load, "S-bend"

Attenuation change  $\Delta\alpha$  during and after testing at highest wavelengths  
1550 nm  $\pm$  25 nm and 1625 nm  $\pm$  25 nm

### Test results:

- **Attenuation change  $\Delta\alpha$  during the test**

TS (short-term) min. value	at 1550 nm	$\leq 0.18$ dB
Spec. 1600 N, actual 1000 N (2 cycles)	at 1625 nm	$\leq 0.19$ dB
TL (long-term)		
Specified 2000 N (1 cycle)	at 1550 nm	$\leq 0.23$ dB
	at 1625 nm	$\leq 0.64$ dB
- Attenuation change  $\Delta\alpha$  after removal of load < 22.5 dB  
(014) TS min. value, specified 1600 N, actual 1000 N (2 cycles)  
(017) TL specified value 2000 N, actual value < 2000 N  
(Recovery time approx. 1.5 hours)
- **After visual inspection without magnification, no damage to the sheath and/or cable elements**
- **Cable were very wavy**
- **The standard does not lay down any method of assessment.**

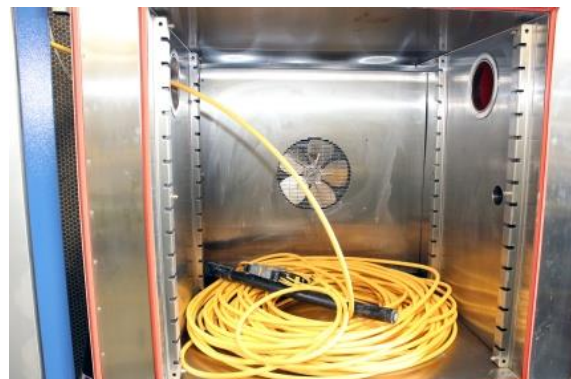
Fig. 1

After a recovery period of approx. 24 hours, a length of approx. 85 m (measured from 7 c) was taken from the wavy part of the tensile-stressed cable sample and laid in a climate chamber. Here it was subjected to temperature cycling tests according to DIN EN 60794-1-2/F1, for the purposes of fault analysis.

TA +60°C high temperature/ 6 h and  
TB -20°C low temperature / 6 h  
4 cycles  
Temperature change 1°C/ min

## Test layout

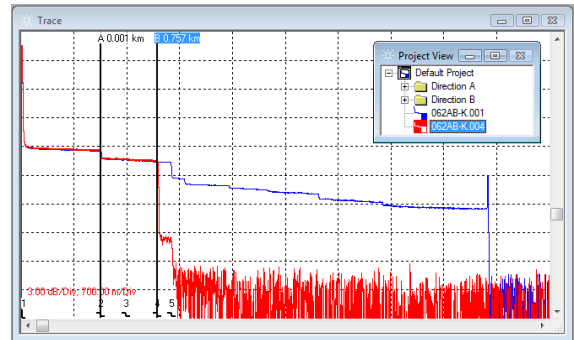
Fig. 2

Approx. 12 hours after the start of testing at temperature TA +60°C, a break similar to sudden increase in attenuation was recorded. (Fig. 2)

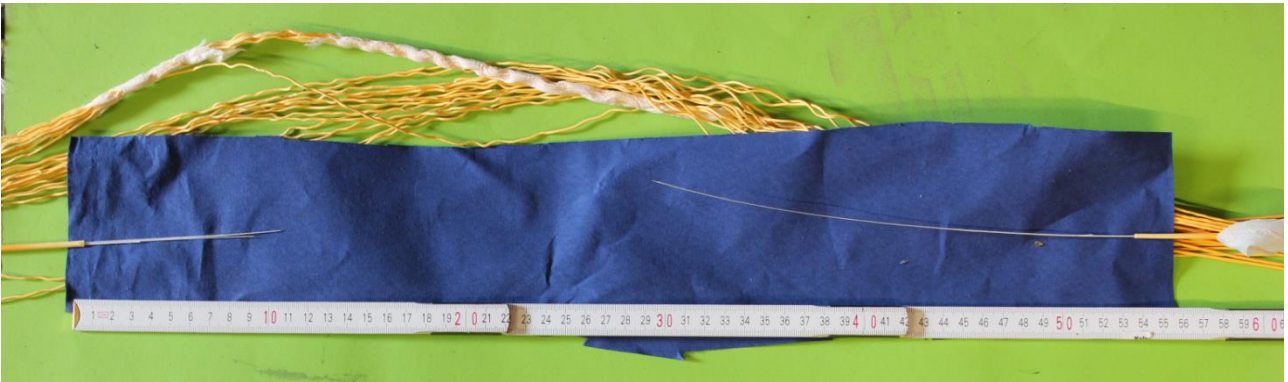
Break No. 1

30 m of the cable sheath were removed for fault analysis.

Visual inspection (not magnified) revealed some damage to the fibre elements  
Actual result: 2 FRP breaks

The first design fault "FRP Ø1.5 mm", causing FRP breakage in fault analyses Nos. 2 and 3.

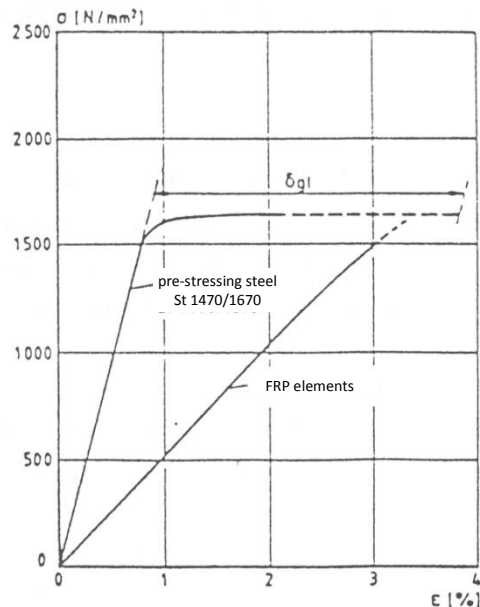
Fig. 1: Comparative stress-strain relationships of pre-stressing steel and FRP elements

As can be seen in Fig. 1, a linear stress-strain relationship (elastic behaviour) can be observed in the FRP up to loads of approximately 1000 N/mm<sup>2</sup>. This was not surprising, as the glass fibres mainly involved in the load transfer are generally considered to be extremely elastic. The subsequent values showing a disproportional increase in elongation are probably due to incipient fibre breakage.

The diagram also shows that there are considerable differences between the stress-strain behaviour of pre-stressing steel and that of FRP elements. The elastic modulus for FRP elements within this service load range is 51.000 N/mm<sup>2</sup>, which is only 25% of the corresponding value for pre-stressing steel. This is of course an advantage with regard to the loss of elasticity caused by the shrinkage and creep of concrete, for example.

What is also noteworthy is the absence of an extended area of deformation before actual fibre breakage, which is present in the case of pre-stressing steel. This property of steel is useful as a warning that breakage is about to occur, but is compensated for in the glass fibre rods by the relatively high elasticity they still possess beyond the service load range.
